Manhole Inspection Summary

Manhole # S43A2_001MH

Insp Date: **12/19/07 1:53 PM**

Location Address: **1201 E Patapsco Ave**

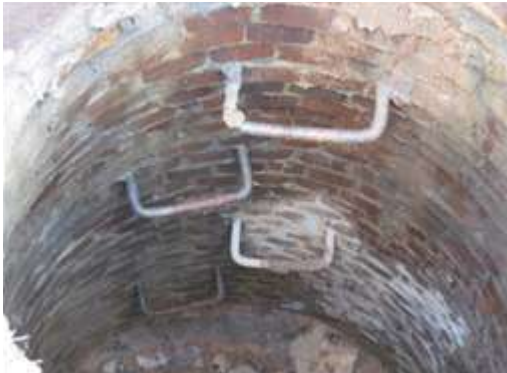
Steps

Count: **4** Missing: **0** ☐ Corroded

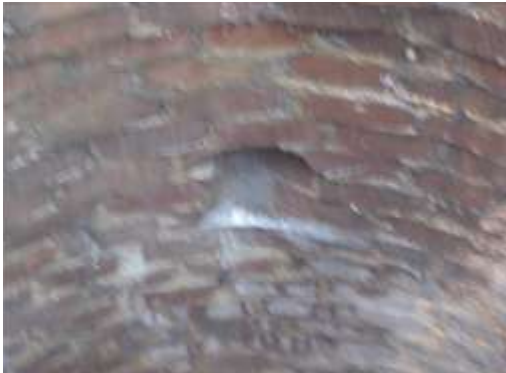
Defect 2

Condition: ☐ Sound ☒ **Cracked** ☐ Root Intrusion ☐ Loose Brick ☐ Deteriorated

Crack

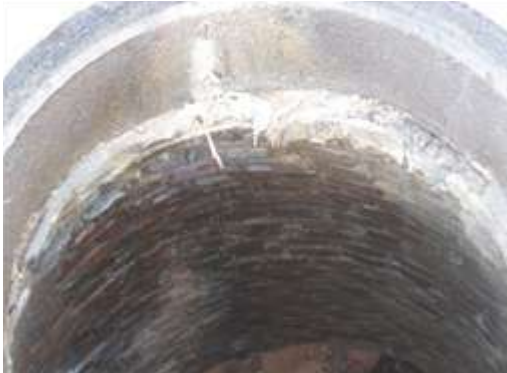
Defect 1

Offset: **1.5** (in.)

Frame offset

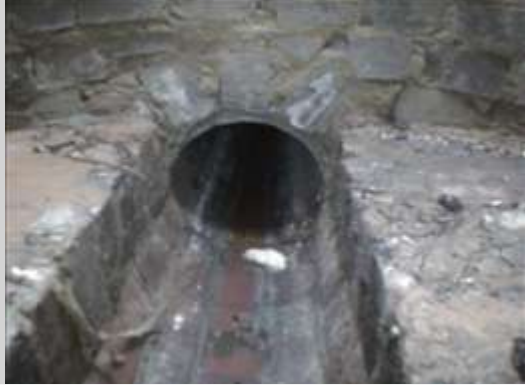
12 O'Clock Outflow

8 in. Circular Gravity Sewer
Pipe Out @ 12 O'Clock

Infiltration: **None** Pipe Seal Cond: **Sound**

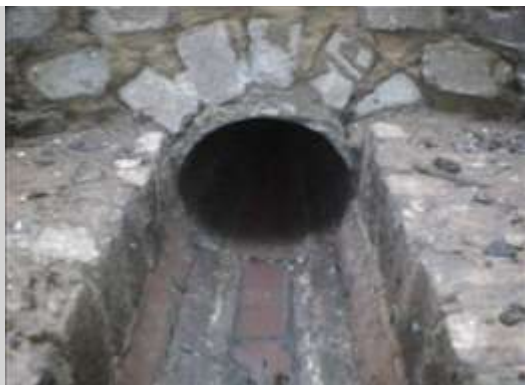
6 O'Clock Inflow

8 in. Circular Gravity Sewer
Pipe In @ 6 O'Clock

Infiltration: **None** Pipe Seal Cond: **Sound**
